## Studies on general test of multi-crop thresher for wheat crop

The Research was carried out in the laboratory of Farm Machinery and Power Collage of Technology, Sardar Vallabhbhai Patel University of Agriculture and Technology, Meerut, for general testing of multi crop thresher on wheat crop, RAMSONS IMPEX made thresher.

The testing was carried out as per the IS: 6284:1985 test codes. The various tests i.e. Checking of Specifications, Checking for Material of Construction, Visual Observations and Provisions of Adjustments, Checking of Safety Provision and Pre-test observation which comes under the general test were carried out. It is observed that during the pre-test observation the parameters like grain crop ratio, moisture content of straw and grain, shaft speed...etc. were found within the specific limits as per standard.

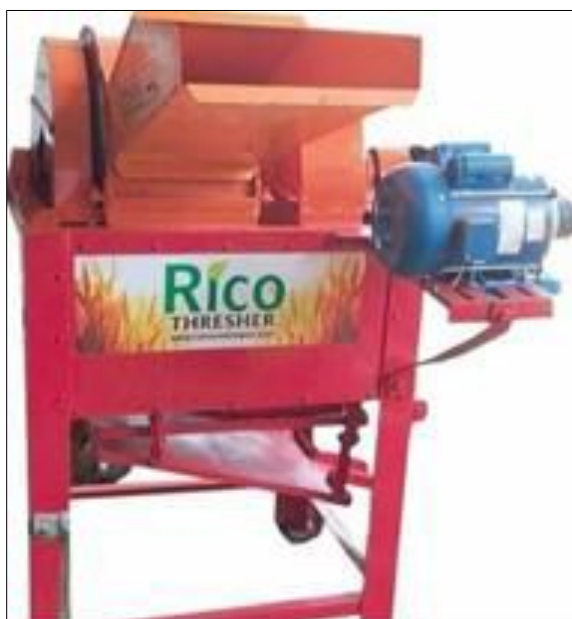
**Plate 1:** Multi-crop Wheat Thresher

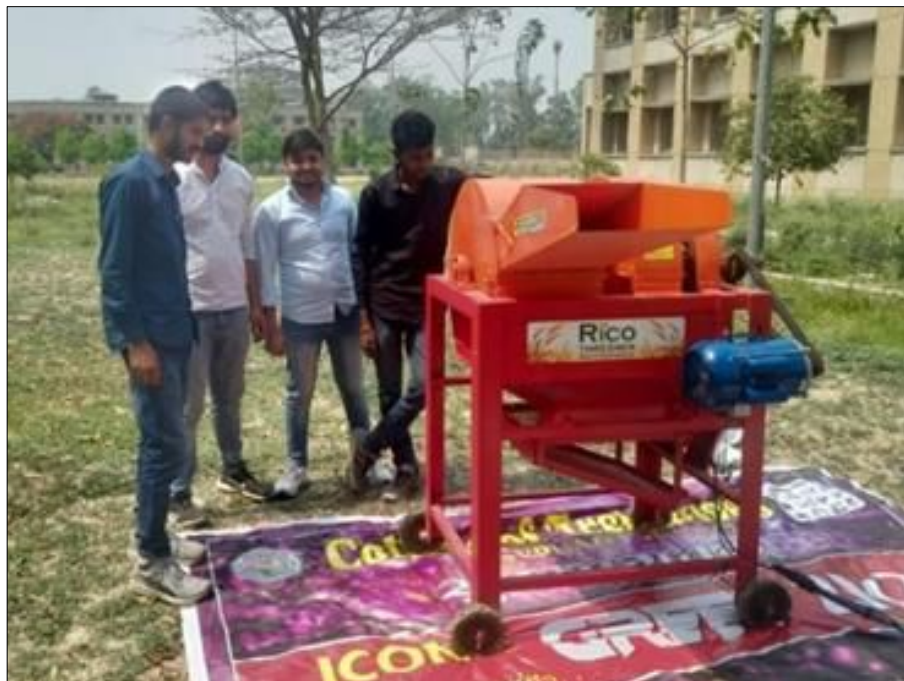
It is very necessary to have the safety measures on the machine for the safety working of the operator. The above table-5 shows the provision of safety provide on thresher from which it is clear that the guards were placed on proper places having the capability of carry the load.

But it is found that there were no any kind of guards provided over the prime mover and transmission system. It is also observed that there was manual type feeding system over the thresher.

**Plate 2:** Inspection of safety provision

It is concluded from the test that the specification and observations were found to be satisfactory but still there are some necessary changes that must be require like provision of safety, repair of transport wheel, feed rate adjustment which is necessary to update for future use.
